Subject: Five-Year Review Report

Superfund Five-Year Review Report

Petroleum Products Corporation Town of Pembroke Park, Broward County, Florida

Prepared for U.S. Environmental Protection Agency, Region IV August 2000

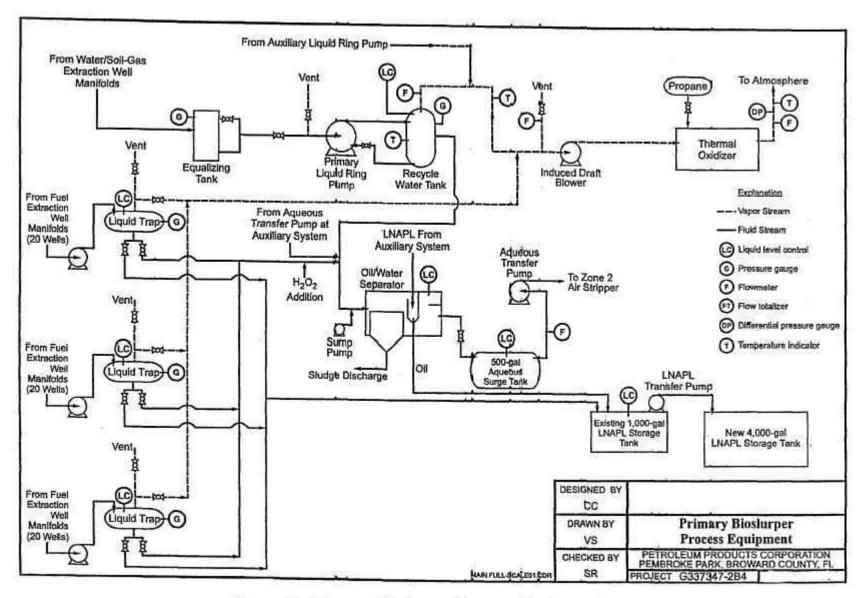
Figure 7. Primary Bioslurper Process Equipment

The bioslurping system was not operating during the site inspection due to treatment system difficulties. The configuration of the bioslurping system is shown in Figure 7. The components and operation of the system are described elsewhere within this report. Some of the bioslurping piping was installed above grade. Since this piping and system is located within the security fence, there should be a minimal concern with any unauthorized tampering of the bioslurping system.

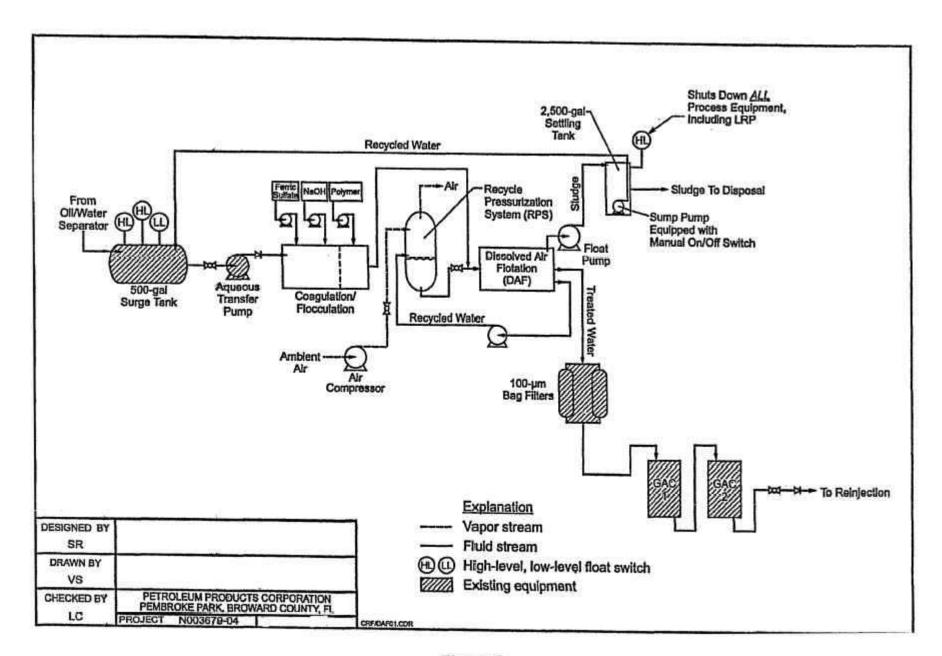
Figure 8

treatment with hydrophobic clay, flow-through centrifugal separation, and in-well separation. Chemical treatment combined with dissolved air floatation was the selected alternative and this treatment system is shown on Figure 8. Approval to commence construction of the dissolved air floatation system with chemical treatment has been granted by EPA and FDEP and this water treatment system should begin operation by mid summer 2000.
